CORROSION PROCESSES ON WEATHERING
STEEL RAILWAY BRIDGE IN PRAGUE

This contribution deals with experimental corrosion tests carried out on the weathering steel railway bridge in Prague. The basic specific property of the weathering steel is an ability to create in favourable environment a protective patina layer on its surface. Since 1968 weathering steel is used under the name "Atmofix" in the Czech Republic and can be used as a standard structural material without any corrosion protection. The weathering steel Atmofix is mostly used for bridge structures and lattice transmission towers. Some of these constructions built in the Czech Republic have been assessed and inspected in the last few years. Authors of this paper developed a new methodology of non-destructive experimental testing of corrosion processes. Testing specimens are installed on typical surfaces of steel bridges in such a way to simulate real conditions of the examined surface. This paper describes results of corrosion tests (thickness of corrosion products, corrosion losses and X-Ray analysis) after one-year exposure, correlation factor and dependence of location.

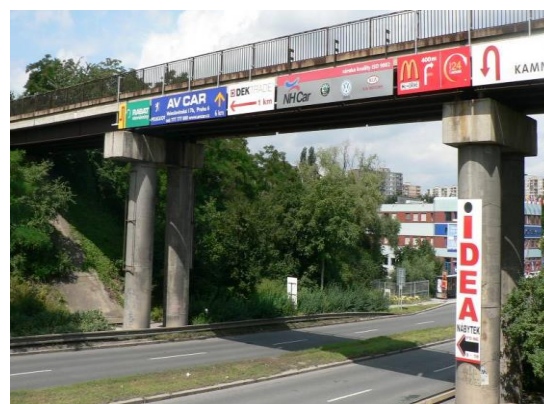
This paper deals with experimental corrosion test on the 3-span composite weathering steel and concrete bridge in Prague. The girder bridge is situated in the capital city of the Czech Republic in corrosion aggressiveness C2. The average annual air temperature achieves 9.8 °C in observed area. The bridge was built in 1981 and the assembling completed in 1983. The steel construction is designed from low-alloy weathering steel Corten B. The supporting construction is created by four main girders designed as welded I-sections. The girders in each of the three spans are designed as 20 m long simply supported beams, see Figure 1. The main girders are connected to each other by crossbeams. The railway track is stored in a gravel railroad bed. Total weight of the steel structure is 155 tons.

Figure 1 Side view on the railway bridge in Prague

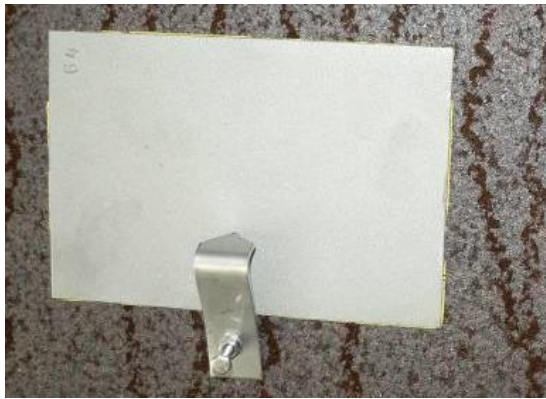
The protective patina layer slows down the corrosion rate [5, 6]. The effects of the expected corrosion losses are typically eliminated by corrosion allowances which are added to the thickness of the structural element calculated in static analyses [7, 8]. The quantity of corrosion losses depends on the position and location of the surface in the structure [9]. The specimens are installed on typical surfaces of the structure. The specimens are flat panels made of steel S355J2WP with a nominal size 150x100 mm and with thickness 1.5 mm [10]. The specimens are attached to the structure with a special anchoring device [11], see Figure 2. Three specimens are installed on typical surfaces of the structure. The specimens will be withdrawn after one, three and ten years of exposition.

Figure 2 Specimens attached by anchoring device

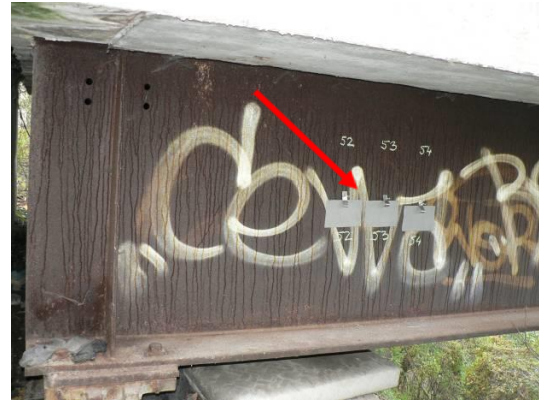
The specimens of surface S2 are installed on the external web of external (southern) main girder close to the western abutment. This surface is not affected by leaking from drainage system even by the proximity of upper or bottom flange, see Figure 4.

Figure 4 Southern external main girder (external web)

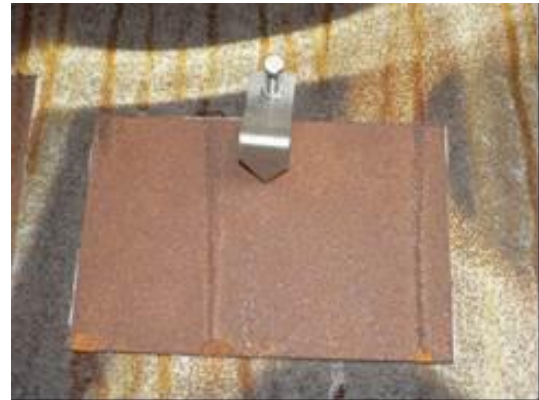
The surface is typical for the whole length of the main girder. Patina layer is uniform, compact and visually favourable. The strips resulting from flowing water on the specimen surface (see Figure 5) demonstrate that the methodology truly reflects corrosion processes on the examined structural members.

Figure 5 Specimens after one year exposure

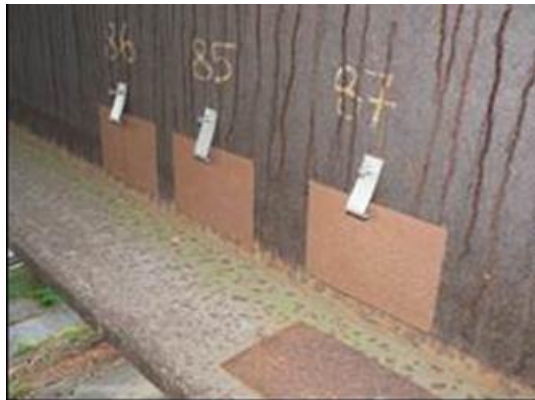
The specimens of selected surface S3 are installed on the external web of external (northern) main girder about 50 mm above the bottom flange. The surface is not affected by water leaking. Visual appearance of patina is typical for given surface, i.e. well-developed thicker and darker patina layer, see Figure 6.

Figure 6 Darker patina layer about 50 mm above the bottom flange on external web of northern main girder

The highest corrosion losses were observed on upper surfaces of lower flanges. The corrosion loss on the external flange is significantly higher than that on the inner flange (the external flanges are generally more influenced by environmental effects). Darker strip of corrosion products on the web close to the bottom flange, see Fig. 6, is only a visual defect and it does not influence the corrosion resistance. The effect of surface orientation (northward vs. southward) is negligible. The results demonstrably show the expected correlation dependence between the measured corrosion losses and the thicknesses of corrosion products, see Figure 7. The correlation factor between both magnitudes is $\rho = 0.98$. The measurement of patina thickness after one-year exposure may serve as a utility for realistic estimation of corrosion rates. The same dependence with high overall correlation factor $\rho = 0.91$ was observed in results from corrosion tests on the road bridge in Ostrava [11] and over the Ostravice River in Frýdek-Místek [12].

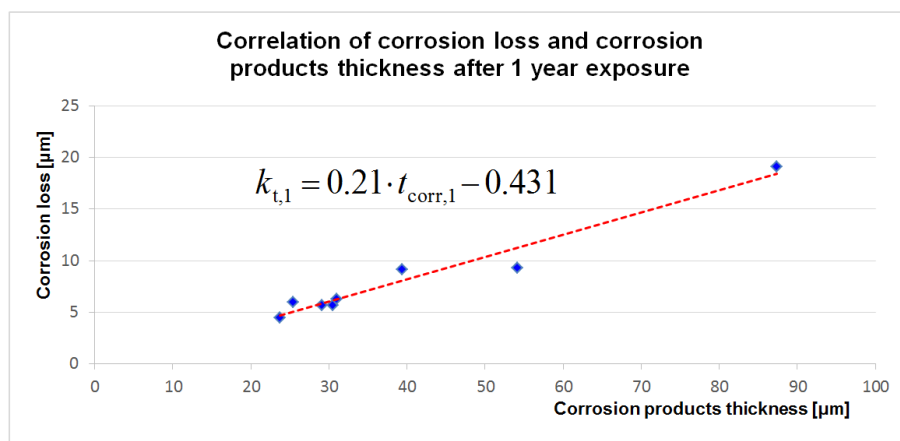
**Figure 7** Graphic relationship between the measured corrosion losses and corrosion products thickness

Surface ID	thickness of corrosion products / μm	thickness loss / μm
S1	25,4	6.01
S2	30,5	5.71
S3	29,1	5.67
S4	39,4	9.14
S5	87,4	19.11
S6	31,0	6.25
S7	23,7	4.50
S8	54,1	9.33
